# SERVICE BULLETIN

<b>SERVICE BULLETIN</b>		No.: MSB-97E52-503	
		Date: 1998-04-15	<b>&lt;Model&gt;</b> (EC,EXP) GALANT (EA0)
<b>Subject:</b> CORRECTION TO METER BEZEL REMOVAL		<b>&lt;M/Y&gt;</b> 97-97	
<b>Group:</b> INTERIOR	<b>Draftno:</b> 97-JY-031		
<b>INFORMATION</b>	OVERSEAS SERVICE DEPT

## 1. Description:

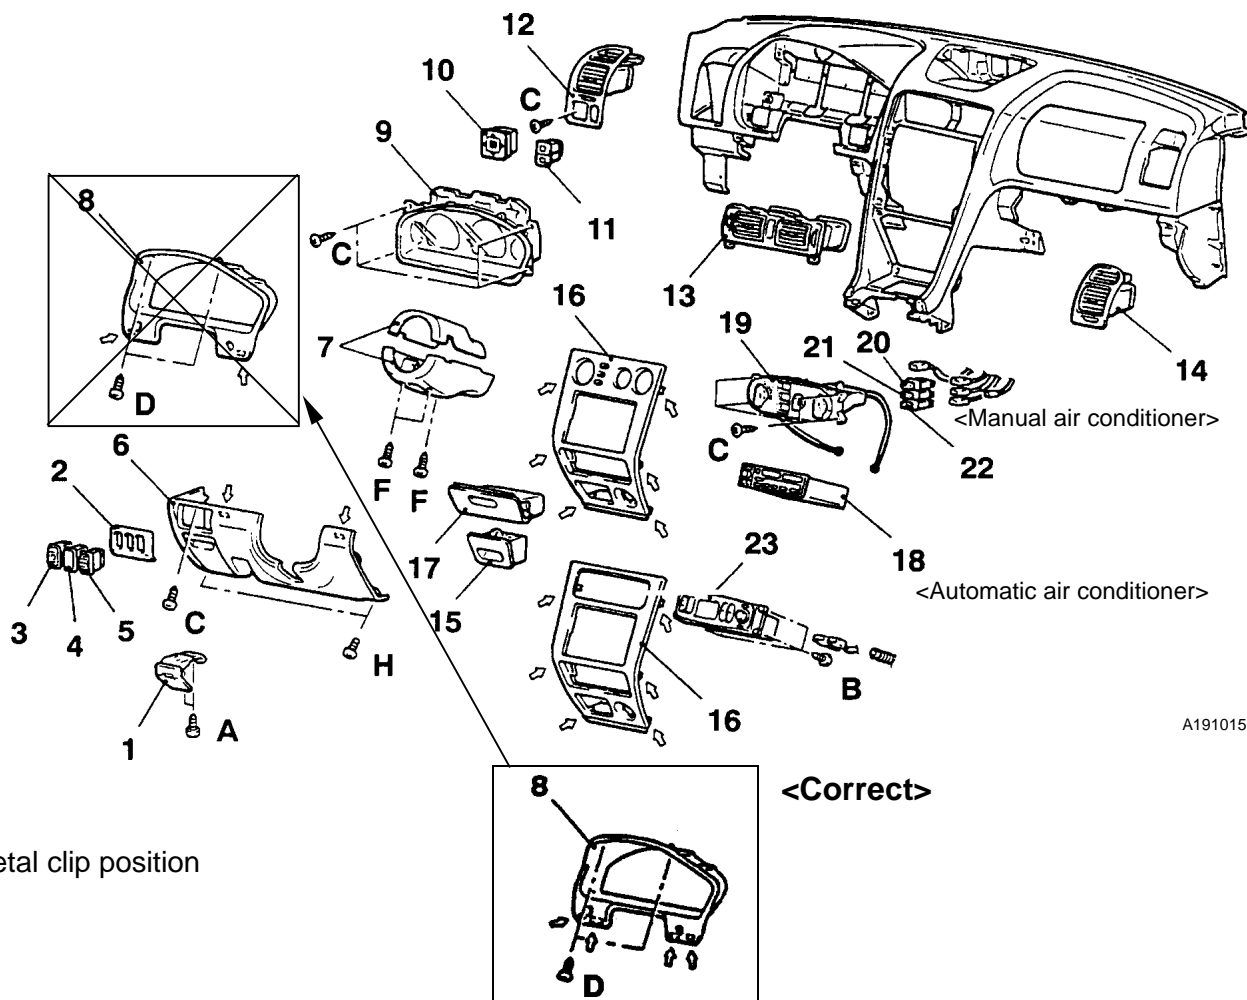
This Service Bulletin informs you that the number of metal clips for the meter bezel should have been four, not two.

← : metal clip position

1. Hood lock release handle
2. Switch bezel
3. TCL switch or auto-cruise control main switch
4. TCL switch or plug
5. Headlamp levelling switch
6. Lower cover
7. Column cover
8. Meter bezel
9. Combination meter
10. Door mirror control switch
11. Fog lamp switch
12. Side air outlet assembly (L.H.)
13. Centre air outlet assembly
14. Side air out
